Marches Mosses BogLIFE Project – Final Monitoring Report

Sophie Laing – Monitoring Officer and Lead Adviser
With Contributions from Ellie Williams – Assistant Project Officer
Edited by Robert Duff - Project Manager
March 2023

Restoring Marches Mosses BogLIFE Project (LIFE15 NAT/UK/000786)

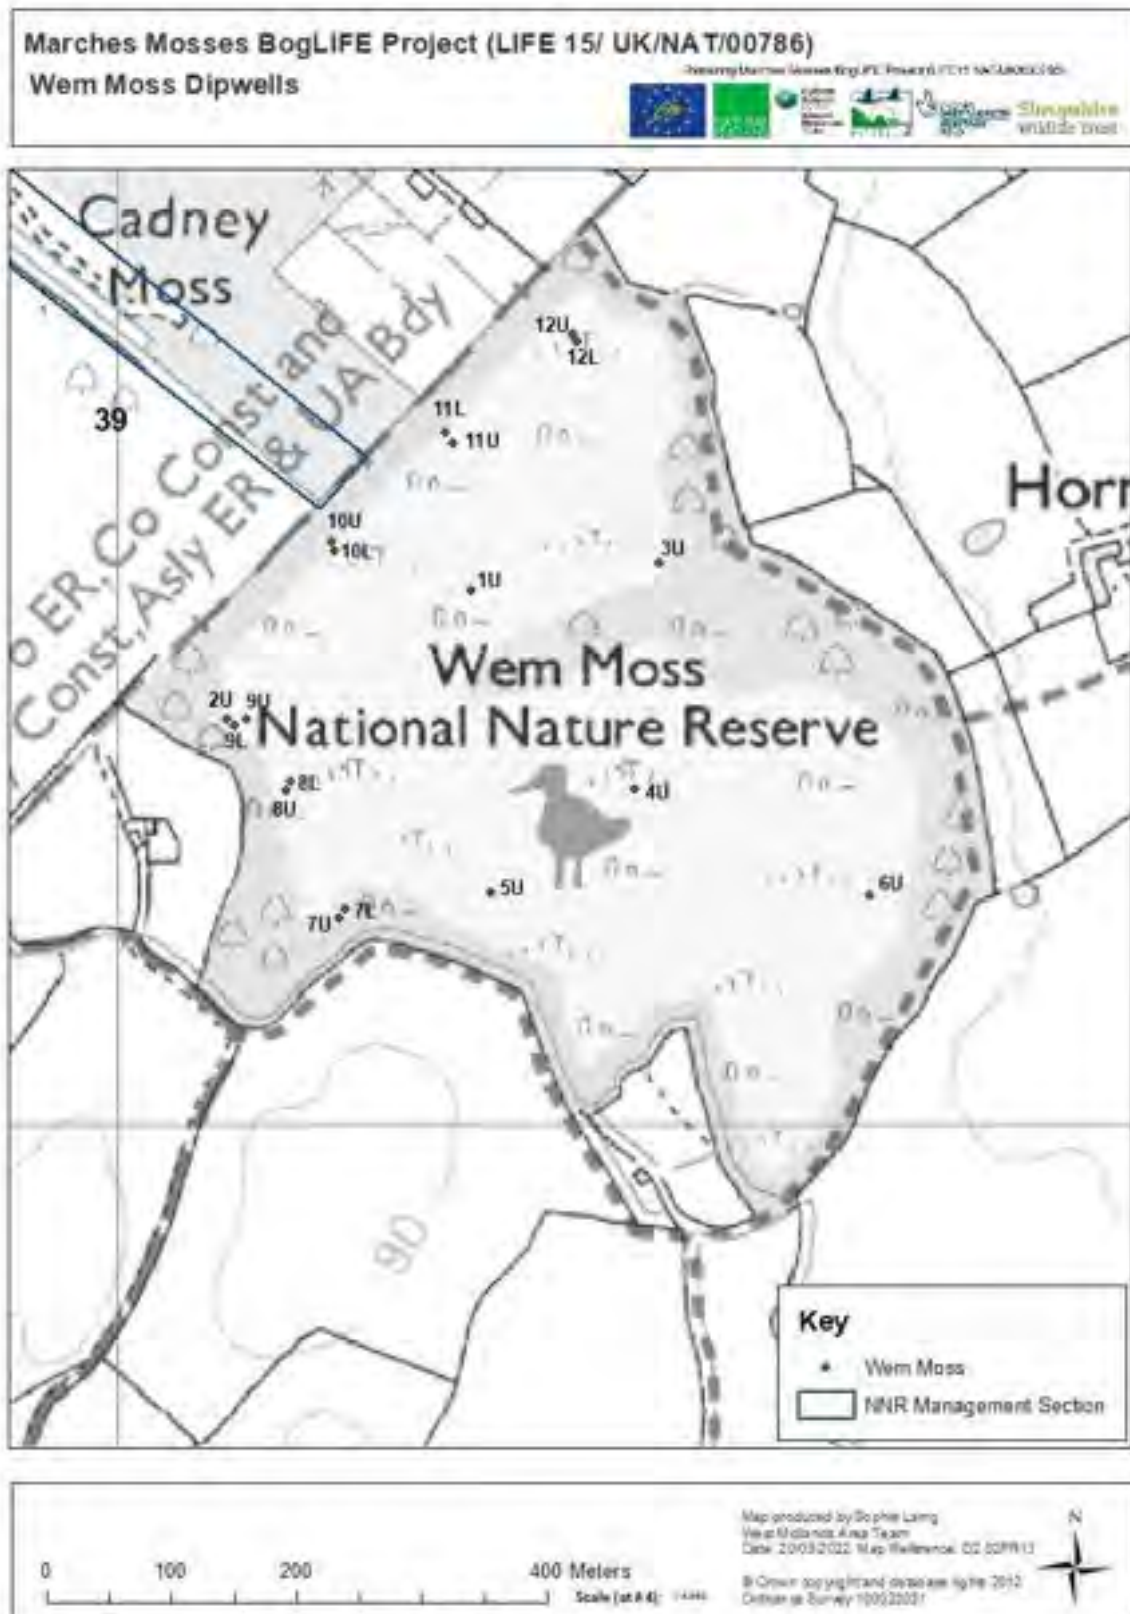
Figure 2.2.2 Location of the manual water level dipwells for the Wem Moss Hydro route.

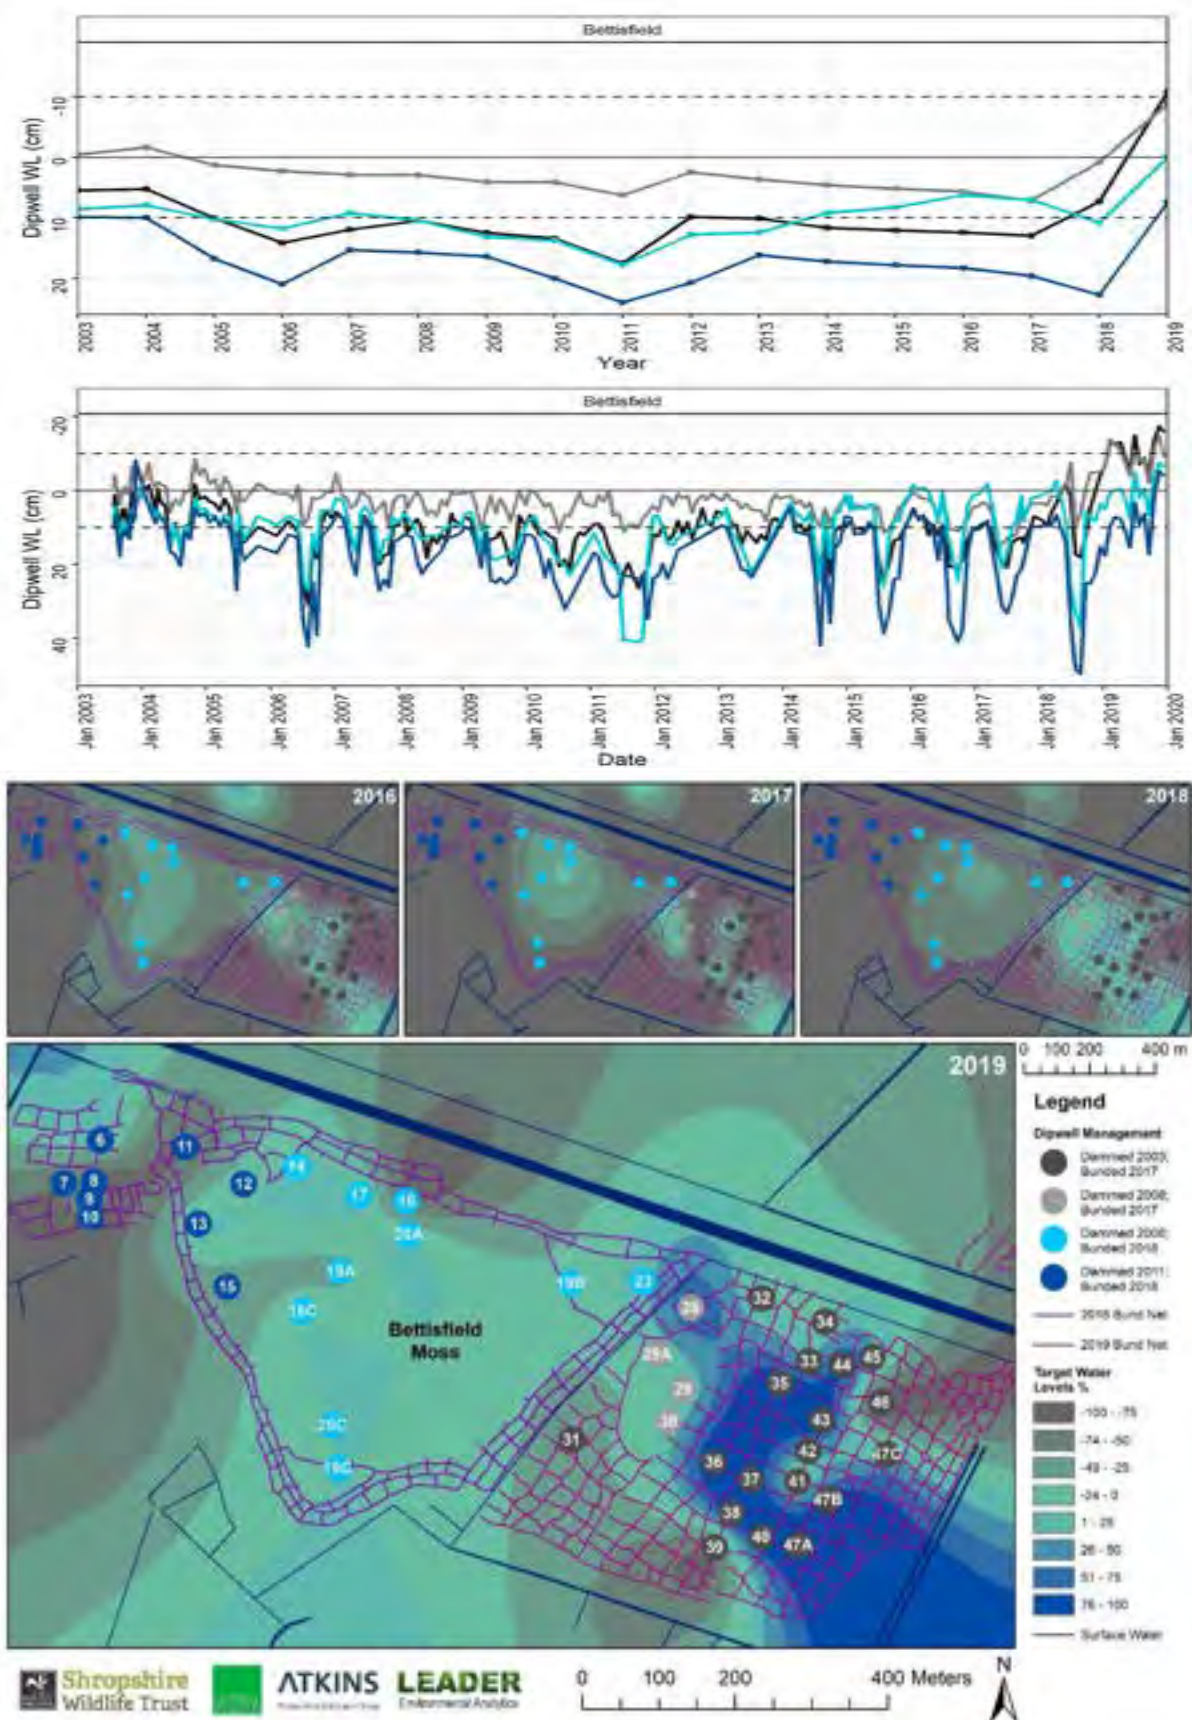
Figure 2.3.1 Graph and map showing water levels over time for different management types on Bettisfield produced by S.Leader from Leader Environmental analyses.

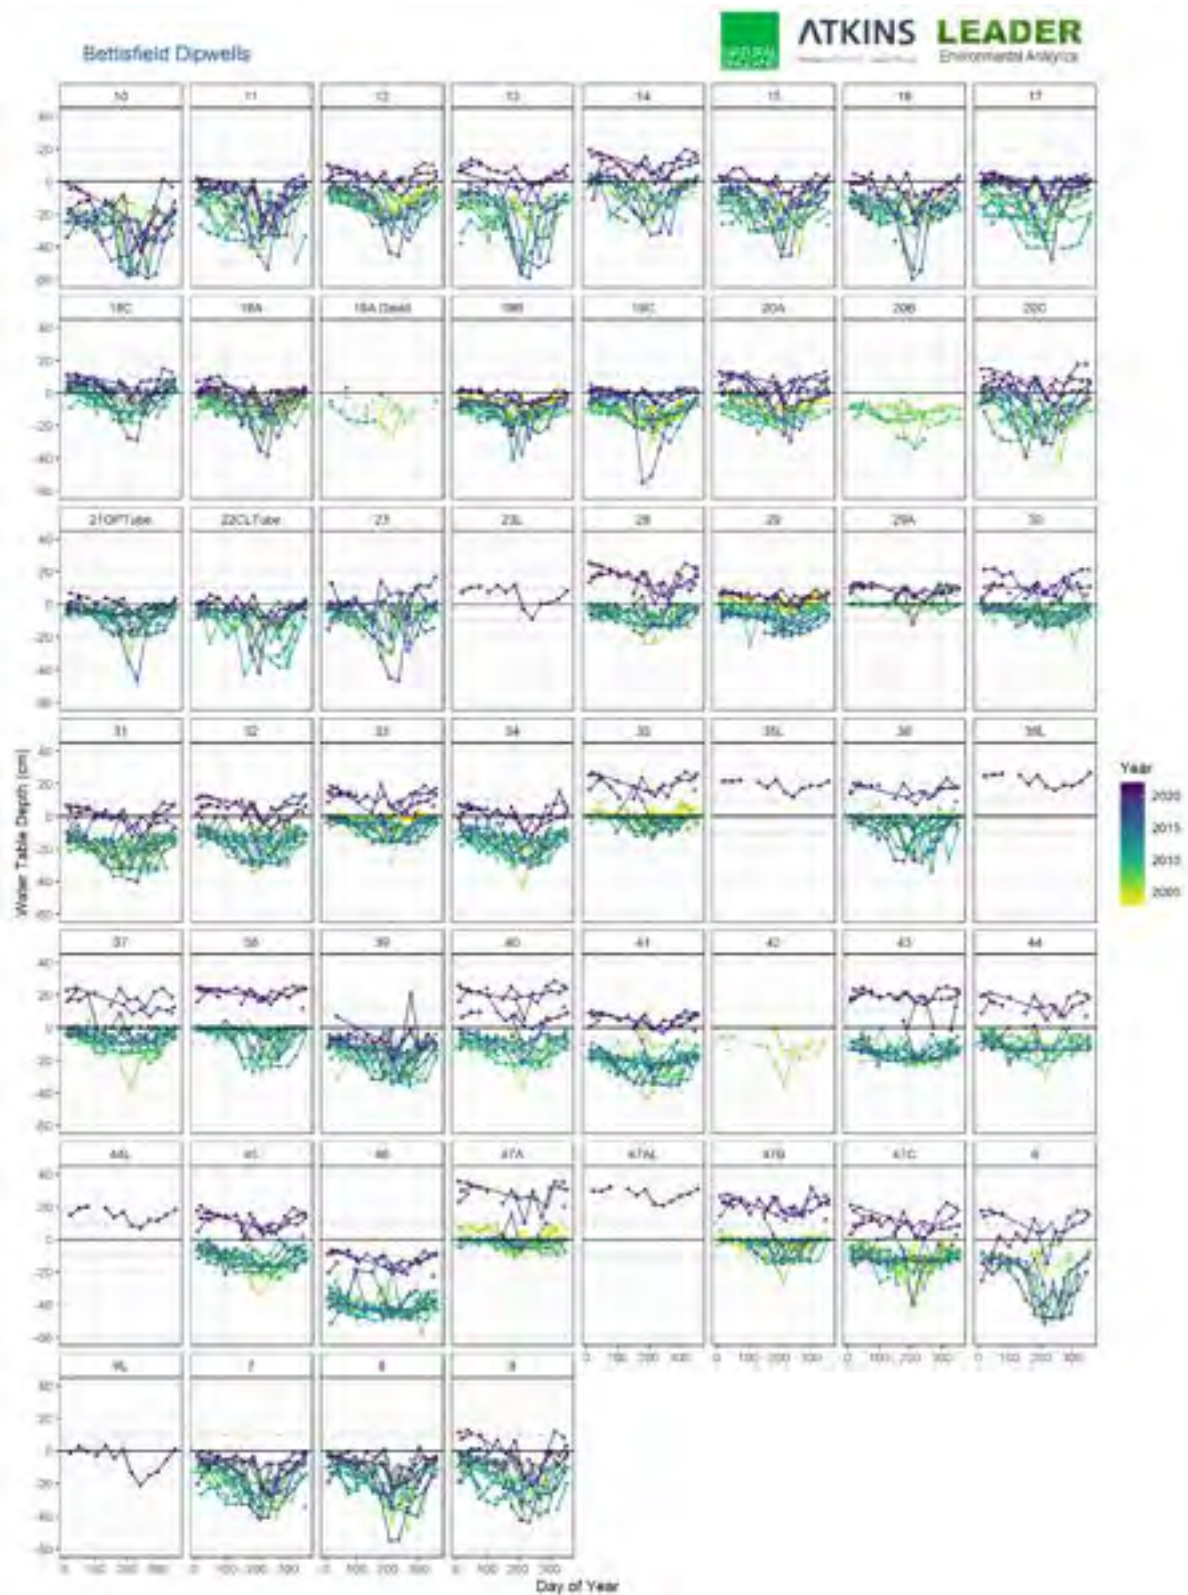
Figure 2.3.2 Overview of Bettisfield Moss dipwell data upto March 2022 plots for annual water levels for each dipwell. Updated by the Monitoring Officer, based on script provided by Leader Environmental Analyses.

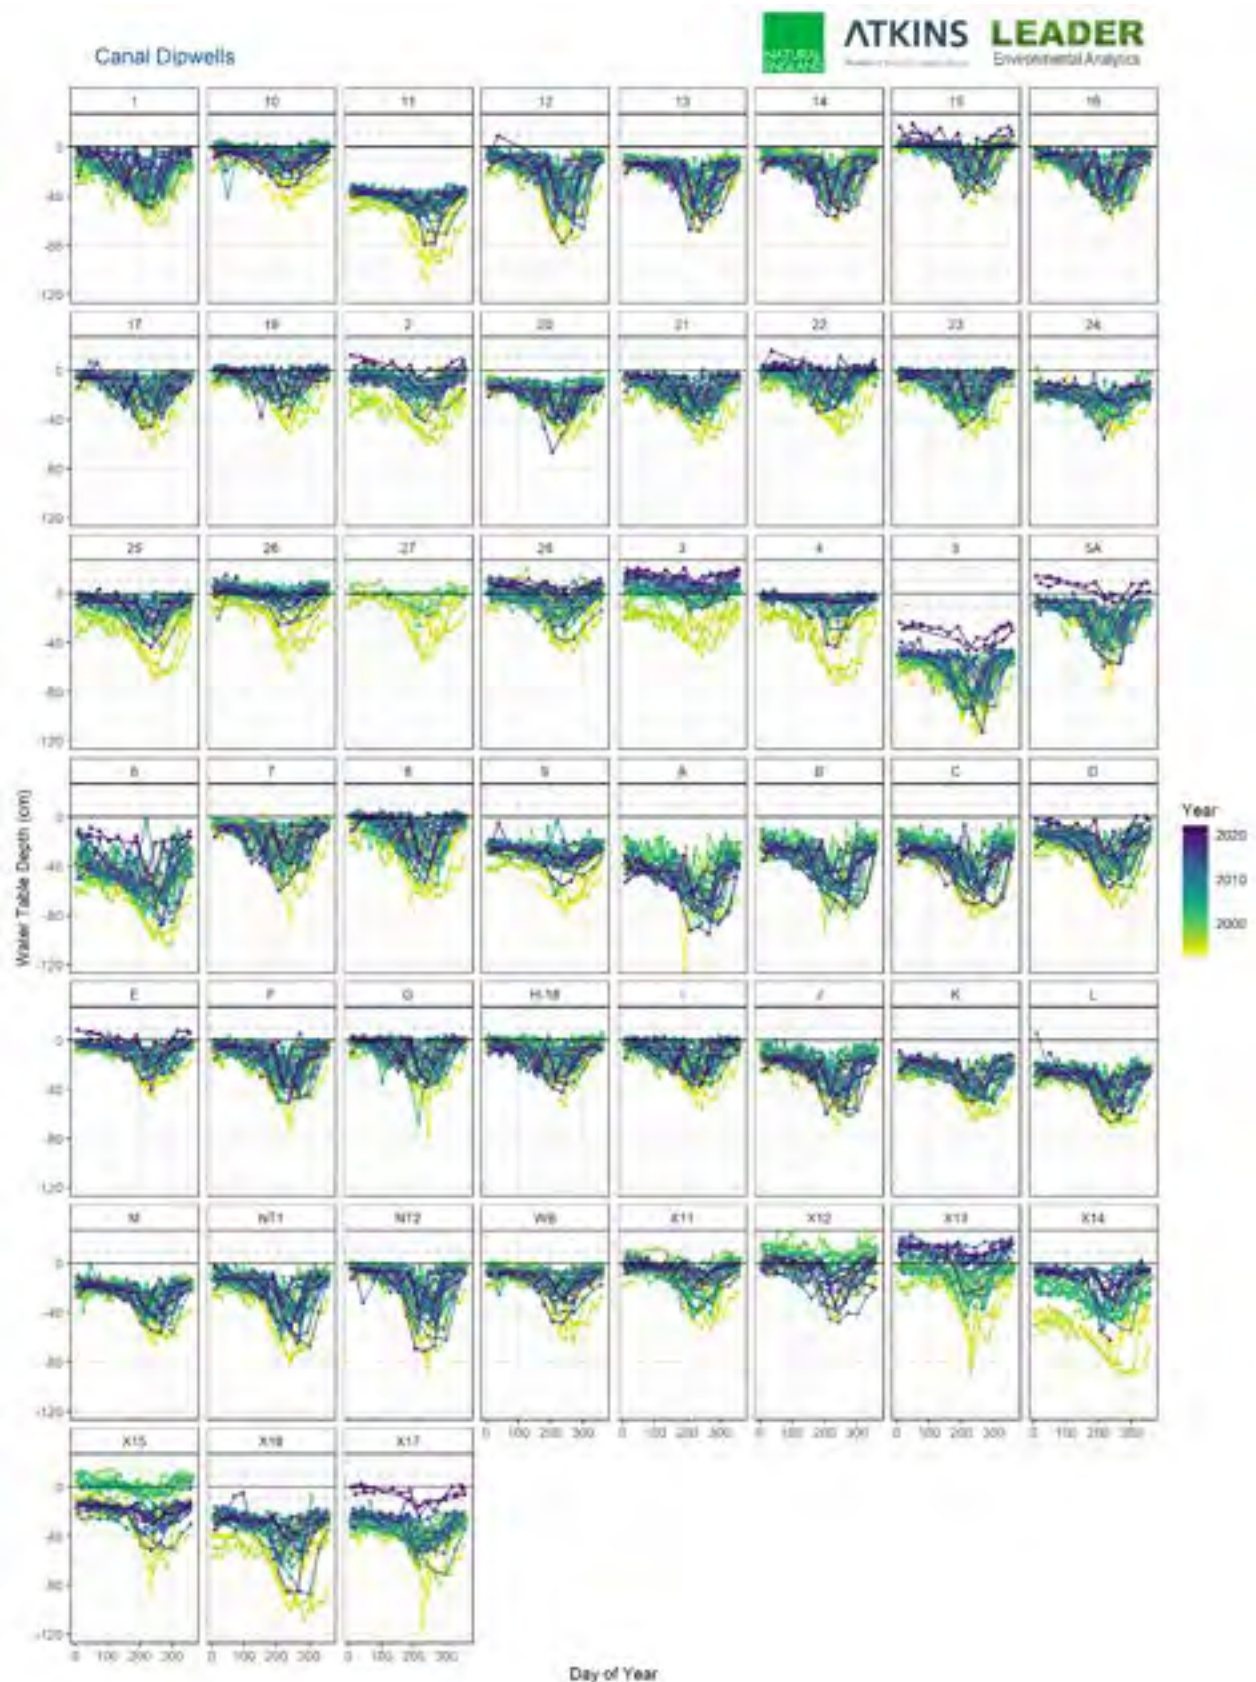
Figure 2.3.5 Updated plots of annual water levels for each dipwell in the Canal route transect across Fenn's and Whixall Mosses. Updated by the LIFE projects monitoring officer, based script provided by Leader Environmental Analyses.

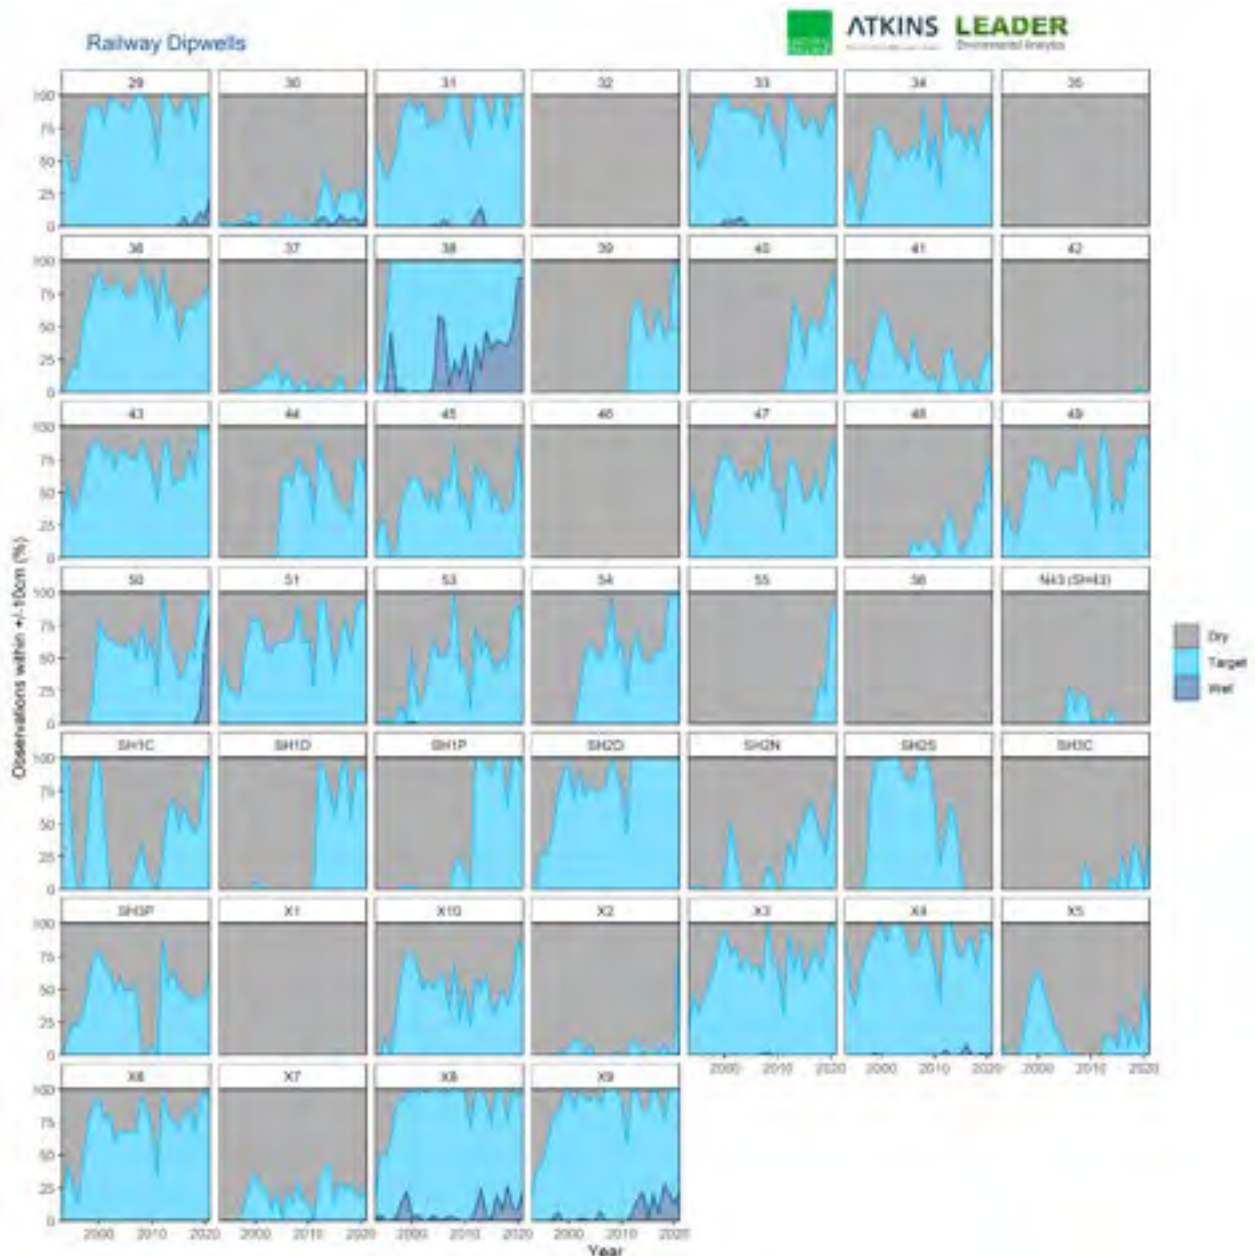
Figure 2.3.8 Updated overview of dipwell water levels along the Railway Route on Fenn's and Whixall (1998 to December 2021). Plots showing percentage of time within target of +/-10cm of the surface. Updated by the LIFE projects monitoring officer, based script provided by Leader Environmental Analyses.

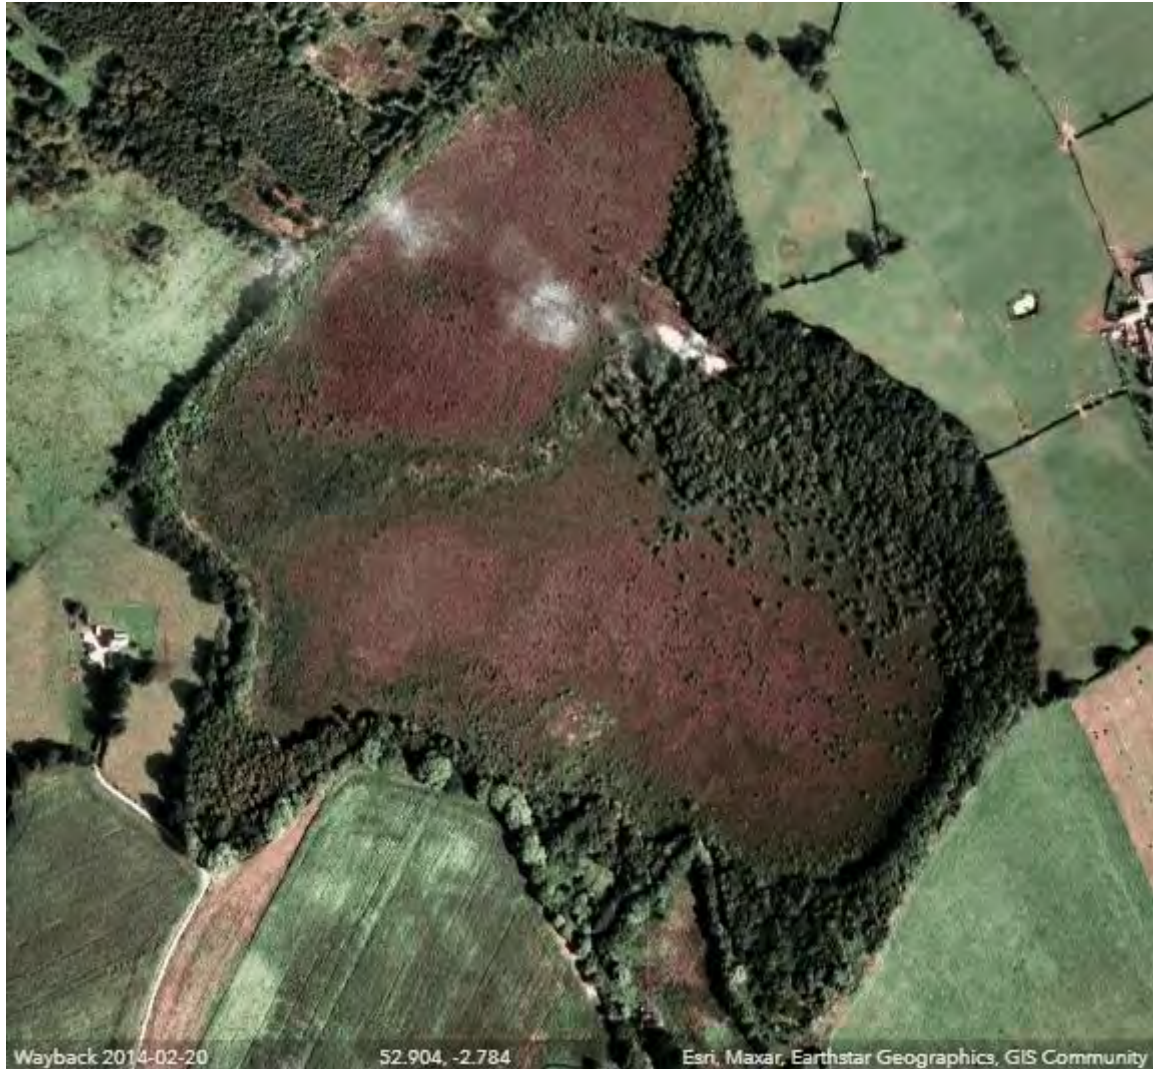
Aerial Photos of Wem Moss before (2014) and after bunding 2021 -CLICK ON IMAGE

within the ± 10 target. Water levels in several of the dipwells such as 1U and 7L located outside the bunding appear to have responded to the re-wetting. Overall, all 22 of the Wem Moss dipwells were within the target range for at least some of the time following the bunding, whereas prior to 2018, 13 had never reached the target range (**See figure 2.3.10**). In 2021 the water levels in 8 of the 22 dipwells met target or above conditions 50% of the time.

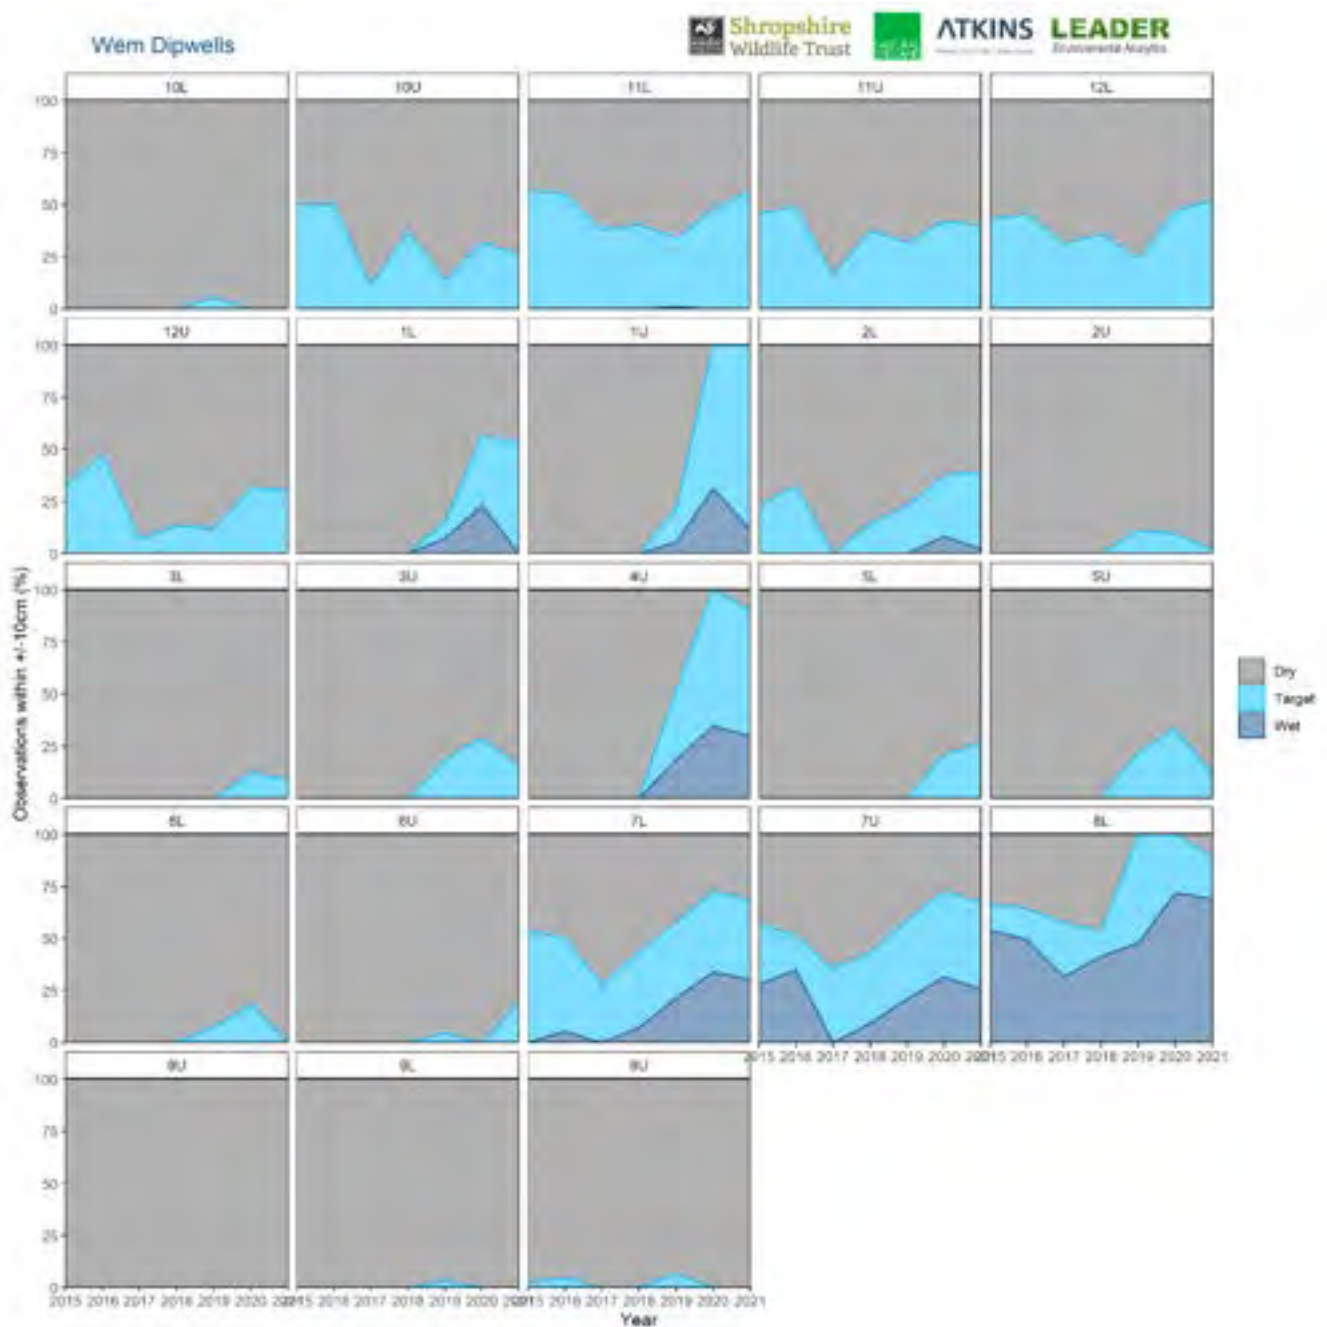
Figure 2.3.10 Updated overview of Wem Moss dipwell water levels between 2015 and December 2021. Showing percentage of time within target of +/-10cm of the surface. Updated by the LIFE projects monitoring officer, based script provided by Leader Environmental Analyses.

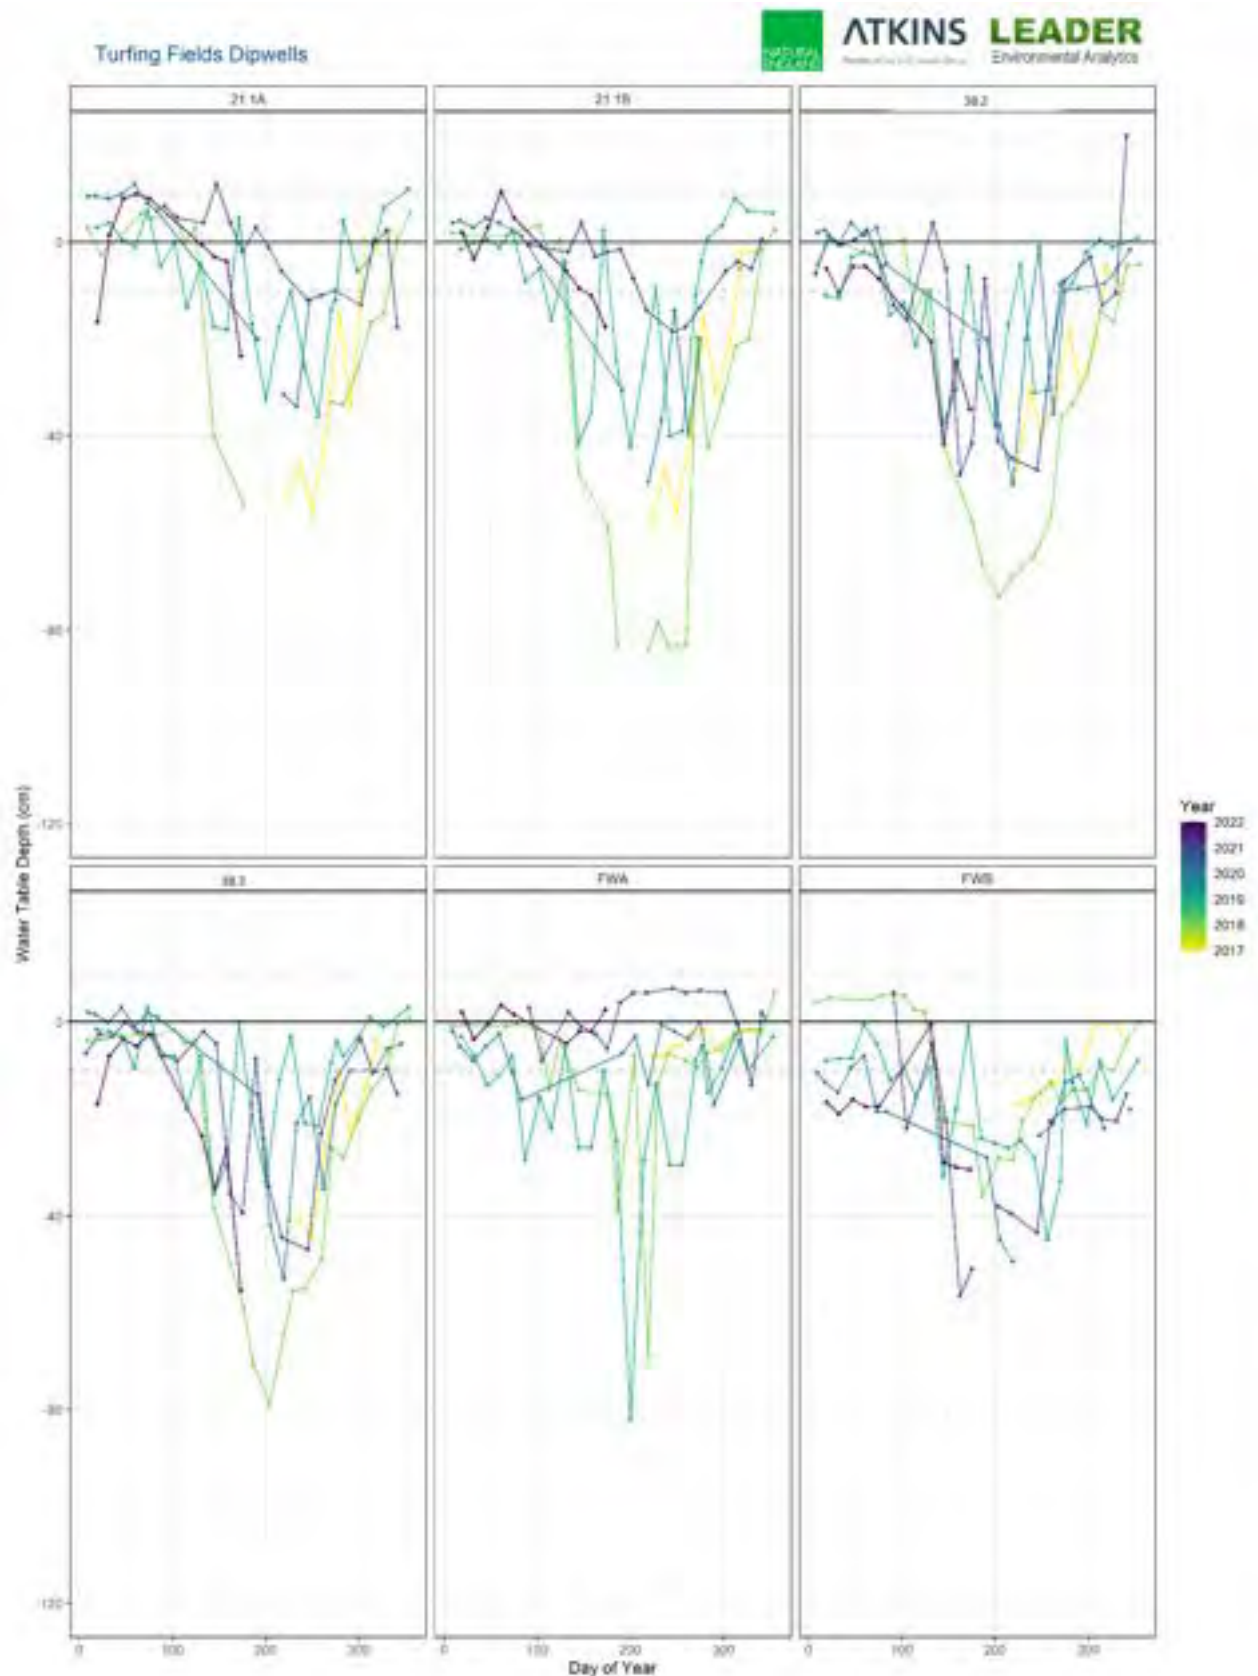
Figure 2.3.11 Overview of Turfing Fields dipwell water level data up to July 2022. It is important to note that works carried out in 2019/2020 caused the ground level to drop by 25cm in the fields (apart from 38.2 and 38.3) but the dipwell data is given referenced to the original ground height.

Turf was stripped from fields 21 and FW but not Section 38. Section 38 therefore provides a 'control' for the comparison of water levels with the other two fields. The full set of the data for the turfing fields can be found in **appendix 2.3.1**. A visualisation of the dipwell data is shown in **figure 2.3.11**. Since the turf in Section 21 was stripped and banded the water levels in two of the dipwells appear more stable with less variability. FWA also appears to show the same trend, however FWB shows a similar trend to the control dipwells in Section 38.

It is worth noting that during the monitoring period the ground level in close proximity of the dipwells remained unchanged whilst surrounding parts of the field were lowered by approximately 25cm by turf stripping. As a result, for the stripped land the actual water table level relative to the new lowered surface level is 25cm higher approximately than is indicated on the results.

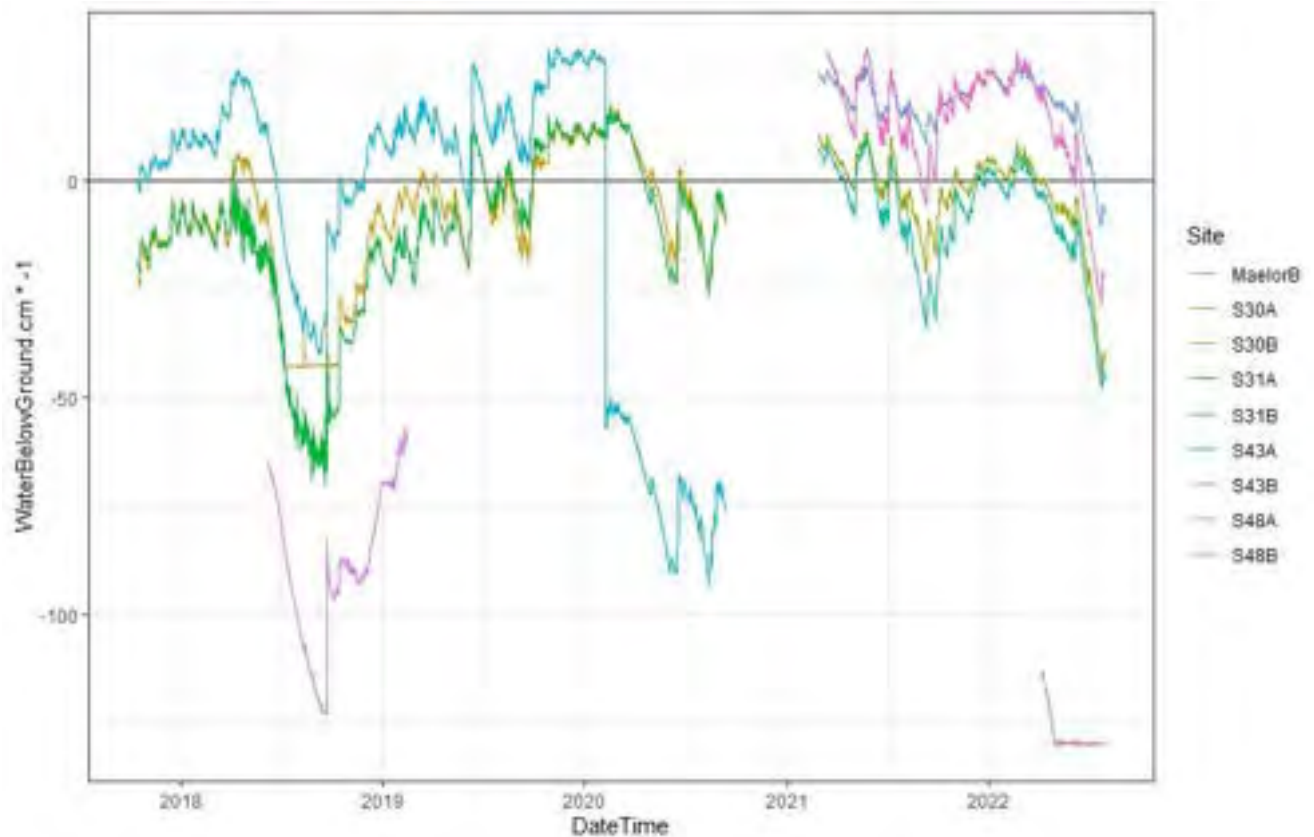
Figure 2.3.13 Overview of water level data from the automated water loggers north of the railway line.

A full set of the Level Scout automated water logger data is found in **Appendix 2.3.4**. Graph plots of the data are shown in **Figure 2.3.13**. The batteries of the water loggers had to be replaced part way through recording which created a gap in the dataset. Consequently, the data is split between the original data set (**Suffix A**) and a new one (**Suffix B**). The location and type of logger used remained unchanged, so the data shown indicated by Suffix A and Suffix B is directly comparable.

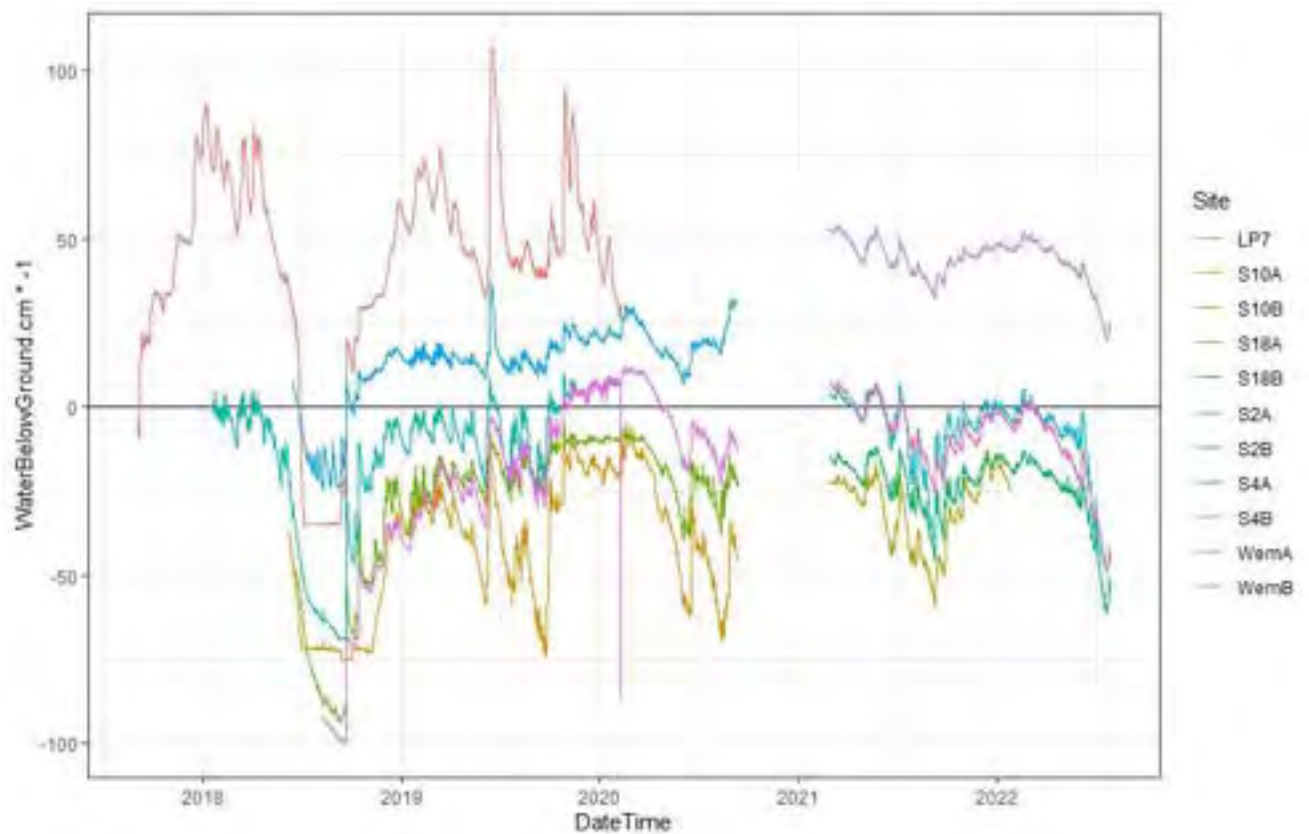
Figure 2.3.14 Overview of water level data from the automated water loggers south of the railway line.

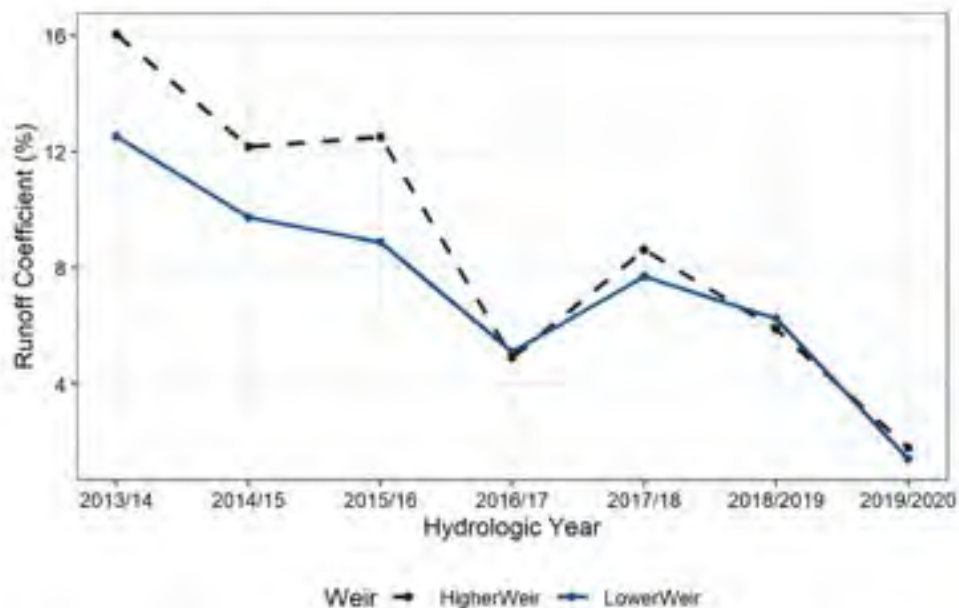
Figure 4.3. Annual runoff coefficients for each hydrologic year (July 1st – June 30th) of the higher and lower weirs.

Water flow data from monitored at two weirs (Main drain, Fenn's Moss) appears to follow a seasonal trend, with peak flows over winter (up to 0.28 m s⁻¹) and zero or near zero flow in the summer months. The runoff coefficient (percentage of rainfall that runs off) shows a decreasing annual trend since 2013, and peaks appear to be occurring later within the year. The runoff coefficient has decreased from 49% in February 2015 to 20% in February 2019 at the higher weir, and from 35% to 18% at the lower weir for the same periods.

Reduced flow, runoff coefficients and higher water table observations in 2019 indicate greater retention of flow within the project site following the restoration management. Further monitoring of flow and water tables would be beneficial to understand how the now completed bunding management has changed the hydrological responses on the Mosses, to understand whether a new equilibrium is established hydrologically, and to observe responses during dry conditions.

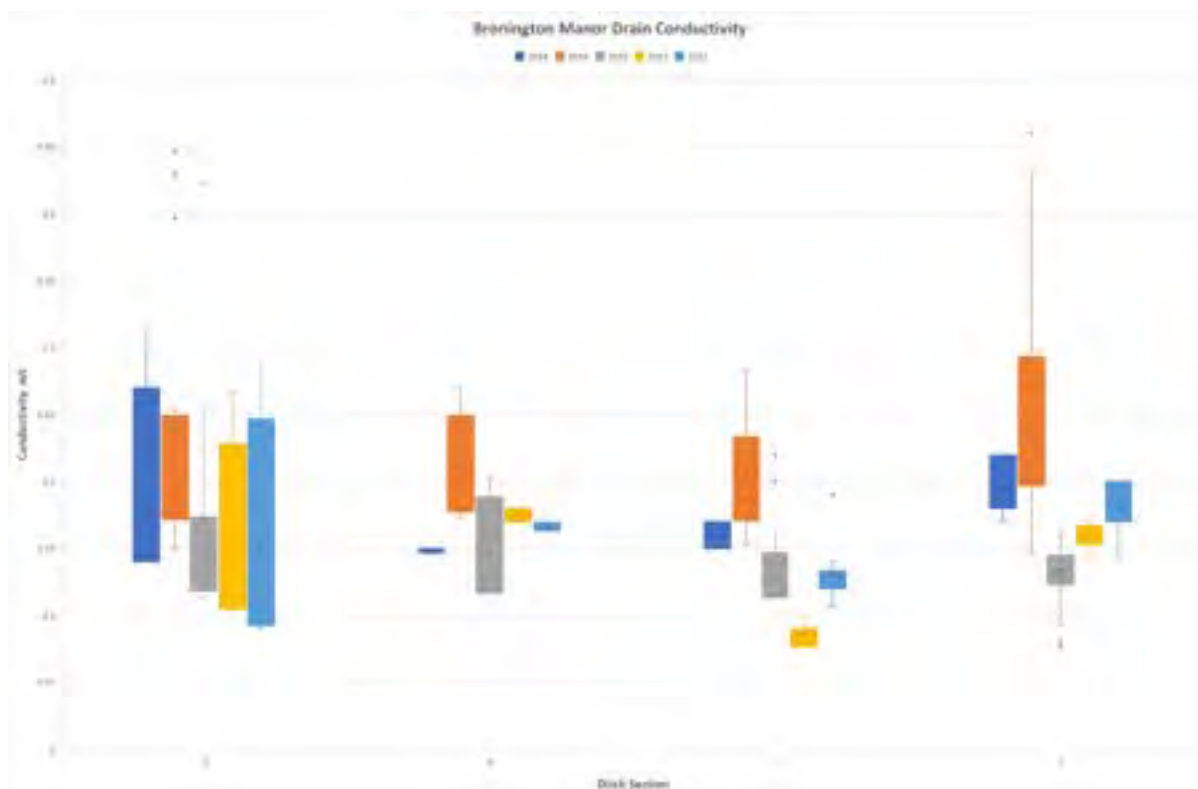
Figure 3.3.4 Graph of conductivity data for the Bronington Manor Drain by ditch section.

Figures 3.3.1 and 3.3.2 show the average winter pH results before (2020) and after the Bronington Manor Drain (BMD) diversion was completed (2022). **Figure 3.3.2** also shows pH results both the original and the new diversion routes. The noticeable lowering in the pH is observed in stretch C of the BMD. This is a section through deep peat that has been dammed up and isolated from the flow of the diverted BMD. It now receives rainwater and ‘bog’ water from the surrounding areas of restored peatland habitat either side. The mean pH for each section of the BMD and the seasons the data was collected can be seen in **table 3.3.1**. This along with results shown **figure 3.3.3** confirm that the pH averages for 2022 in Section C are the lowest recorded. This may be a sign that the original BMD no longer carrying mineral nutrient water is reverting toward conditions you would expect for a peat bog environment. Analysis of conductivity values show no conclusive changes to date (**figure 3.3.4**).

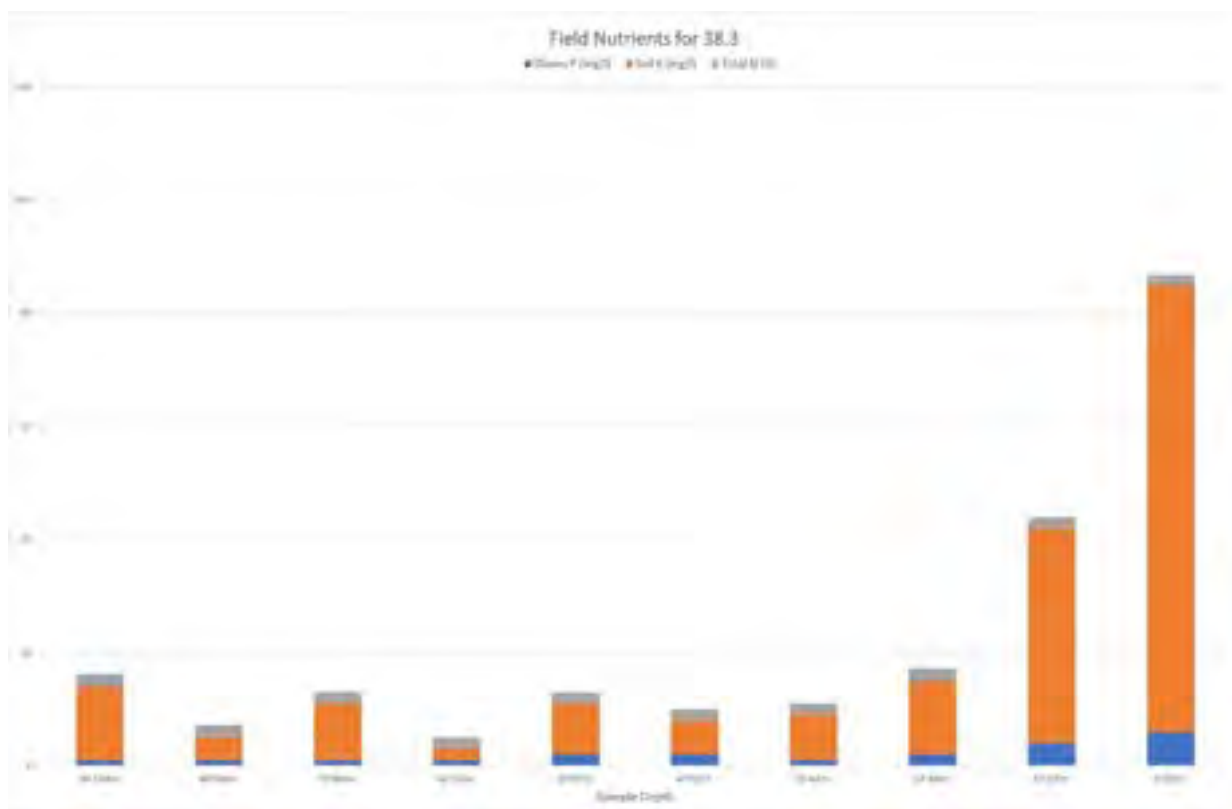
Figure 3.3.5 PKN nutrients by depth for Section 38.3.

The histograms below show results for full soil profile samples however full data is contained in **Appendix 3.3.5**. Not unexpectedly given their past agricultural use the turfing fields show elevated nutrient levels in the first 0-10 cm (see **Figures 3.3.5 - 3.3.1**). There was then a steep drop in the 10-20 cm depth, although levels still remained elevated. Below this however the nutrient levels began to level off in most cases. Section 21 had higher nutrient levels for some of the deeper samples possibly reflecting historic disturbance to the soil layer. All the fields referred to in this part of the report apart from 38.3 and 38.4 were subject to turf stripping.

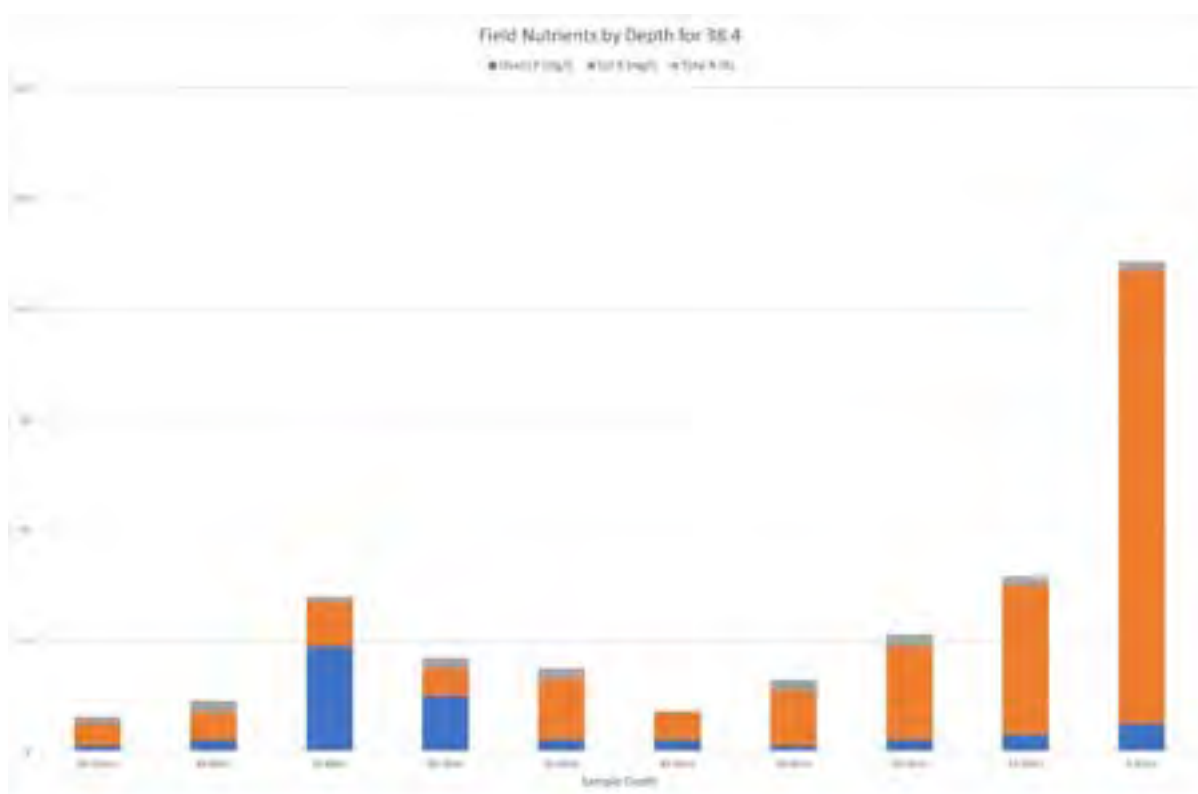
Figure 3.3.6 PKN nutrients by depth for Section 38.4.

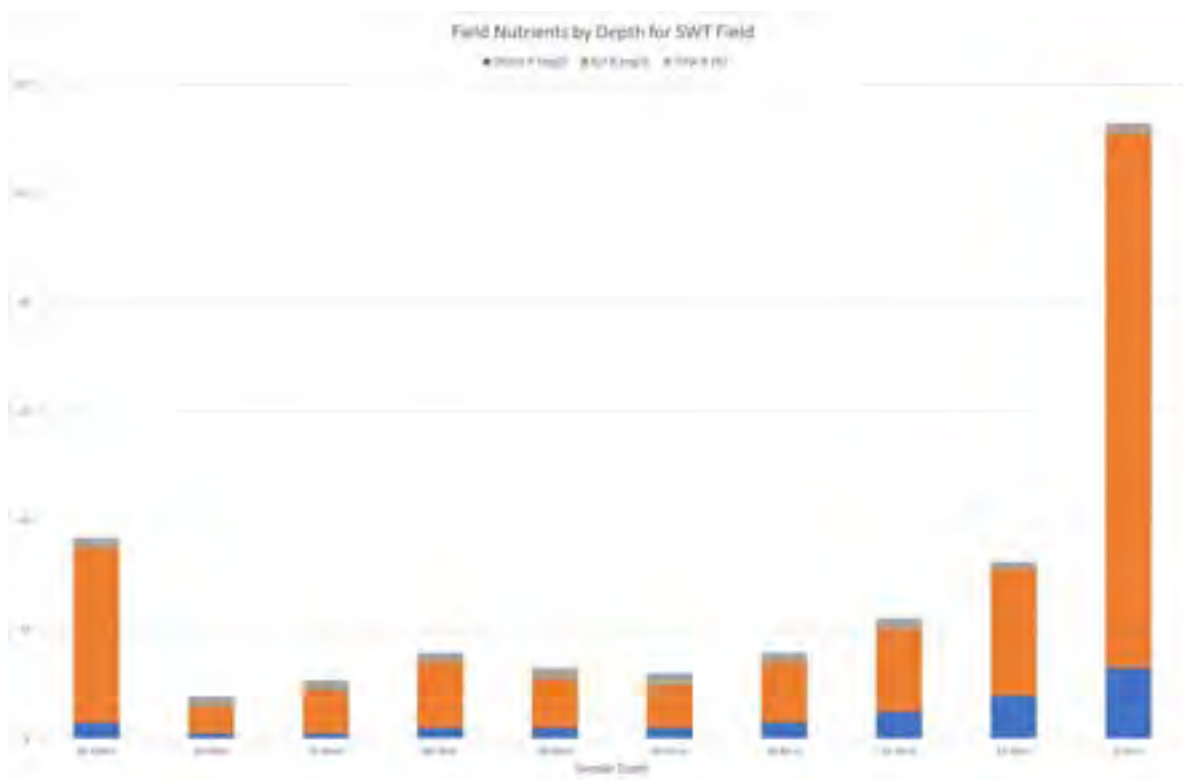
Figure 3.3.7 PKN nutrients by depth for SWT Field.
