Marches Mosses BogLIFE Project – Final Monitoring Report

Sophie Laing – Monitoring Officer and Lead Adviser
With Contributions from Ellie Williams – Assistant Project Officer
Edited by Robert Duff - Project Manager
March 2023

Restoring Marches Mosses BogLIFE Project (LIFE15 NAT/UK/000786)

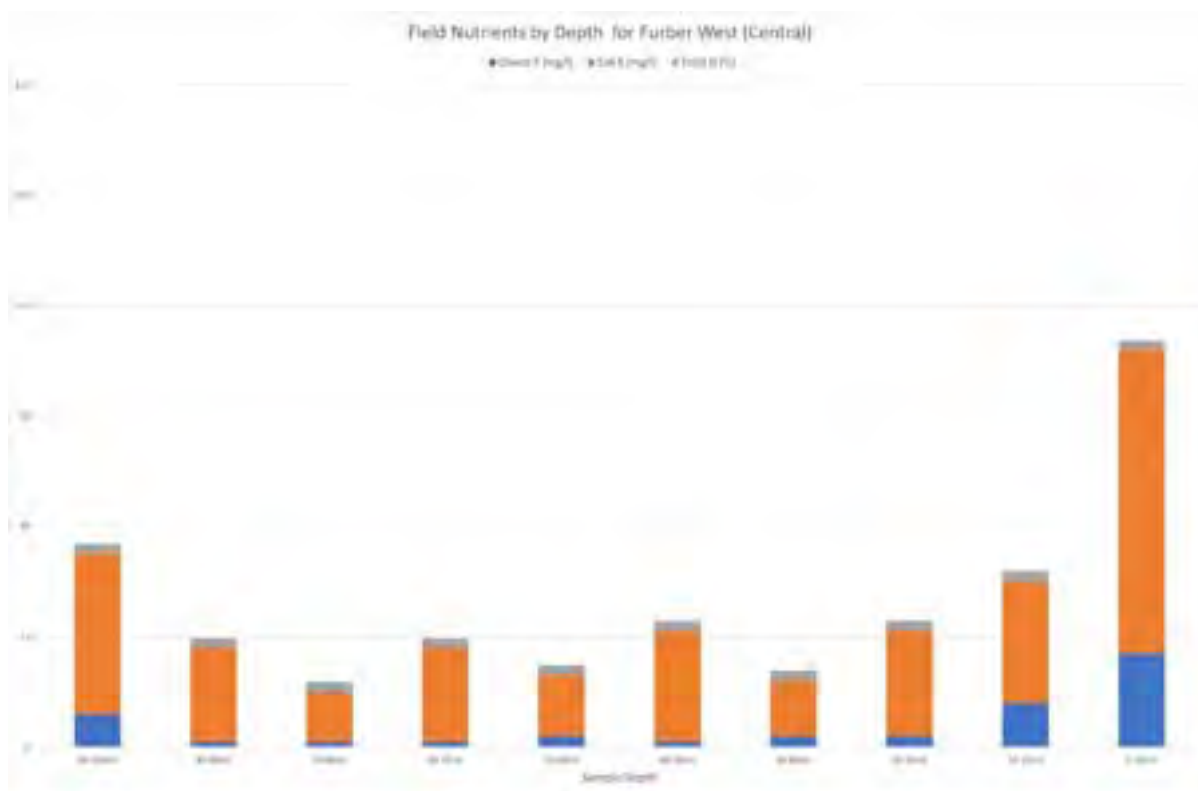
Figure 3.3.9 PKN nutrient by depth for Furber's West (Central field).
